BUILDING-STRUCTURE INVENTORY FORM

Liebeck Farm

Town of Greece Historic Sites Survey
Monroe County, New York
132 Gates Greece Town Line Road
page 3

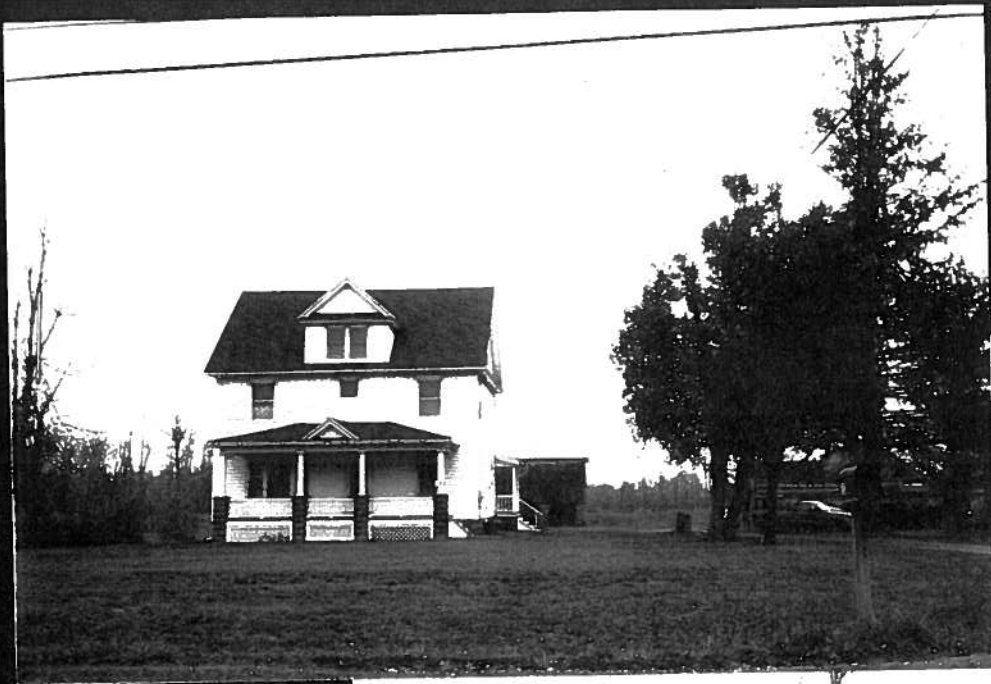
12. PHOTO:

18. Two-and-one-half-story, side-gabled frame farmhouse (c. 1902-1924) with one-story, gable-roofed rear wing. The main section is three-bays wide by two-bays deep. The house stands on a cast concrete block foundation. Exterior walls which are now clad in vinyl siding were probably originally clad in wood shingles/clapboard. Fenestration is regular and symmetrical with mostly 1/1, double-hung windows. A Chicago-style picture window with leaded glass transom and a small, rectangular window with diamond-paned glass are located on the facade (south elevation). A window bay with shed roof is located on the west elevation.

The side gables feature pent roof enclosures across the bottom of the gable. A gabled dormer is located on the south slope of the house.

A one-story porch extends across the facade of the house. It features a shed roof, round columns on cast concrete block piers and an open wood railing with straight balusters. The porch skirting consists of decorative lattice-work screens below the deck.

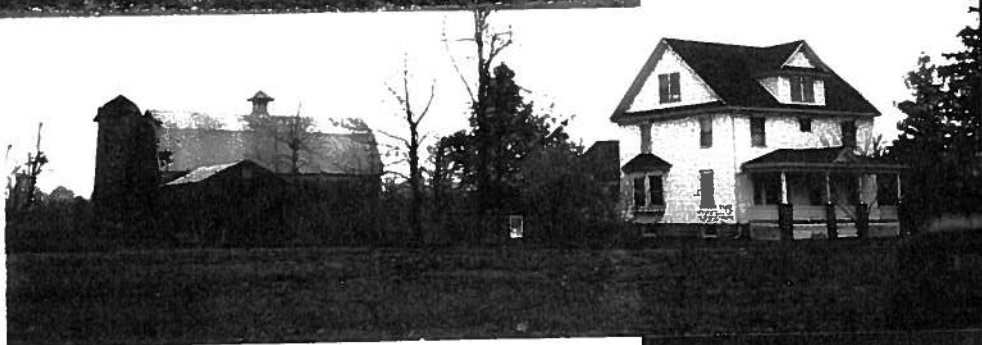
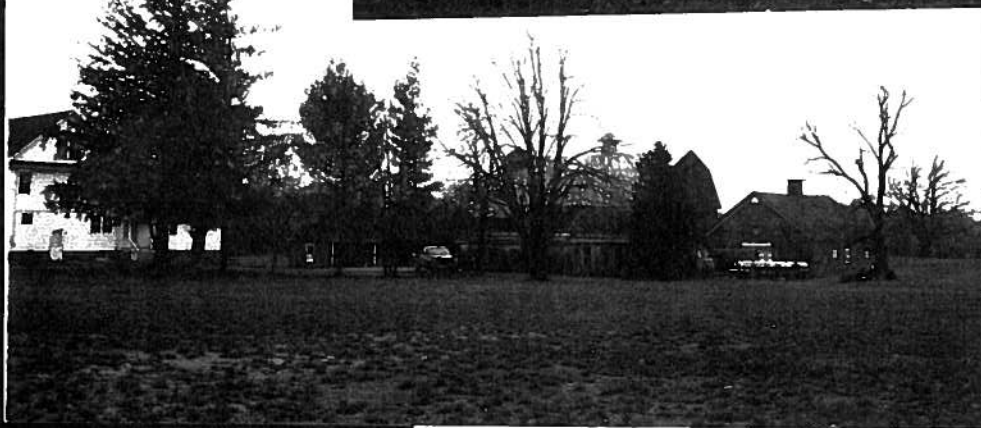
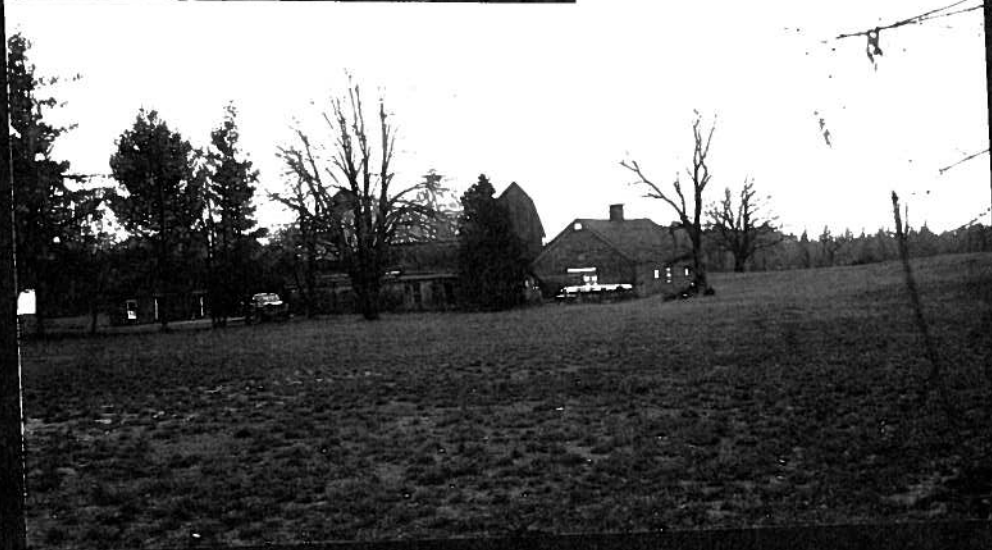
Contributing gambrel-roofed barn (c. 1902-1924) with additions is located directly north of the house. This large banked barn is clad with narrow, vertical wood siding and has a metal roof topped with a square cupola. It stands on a stone foundation. The north elevation features a banked slope leading up to sliding track doors. Adjacent to the west elevation of this barn is a ceramic tile silo. Attached to the south (front) elevation of the large barn is a long, projecting, south wing. It consists of a two-story, gabled, center section and a one-story, gabled, end section. Both are clad in narrow, vertical wood siding. The center section stands on a stone foundation.
